In the Palstek edition 1/2010 we presented a new Cleaning- and Regeneration process for Dacron sails, that caused quite some sensation. It is supposed to clean sails faultlessly and regenerate at the same time the profiling. Jan Kuffel has followed a set of test sails over the full season and draws a balance.

Visually as new

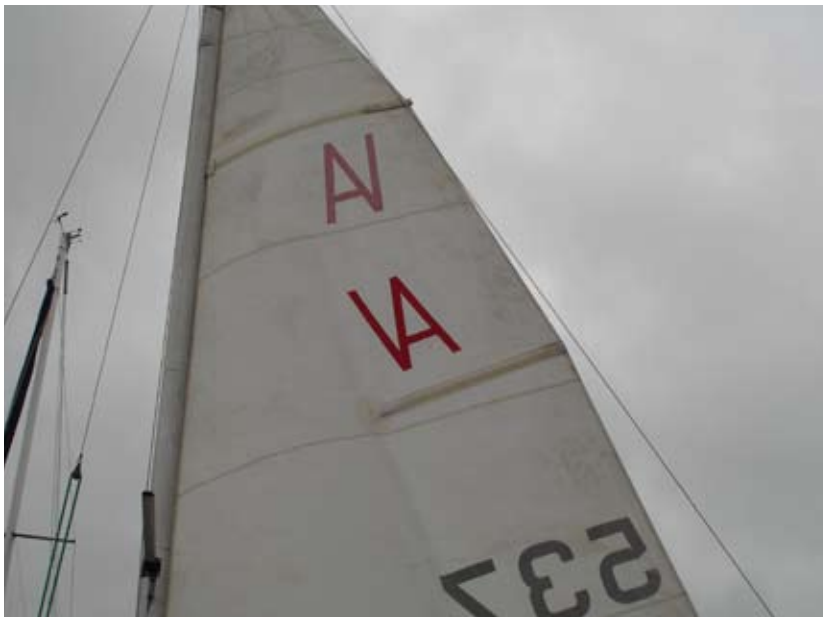
The main was obviously worn out during the last twenty years of use. Rust stains, stretched leeches and a bad shape are the result.

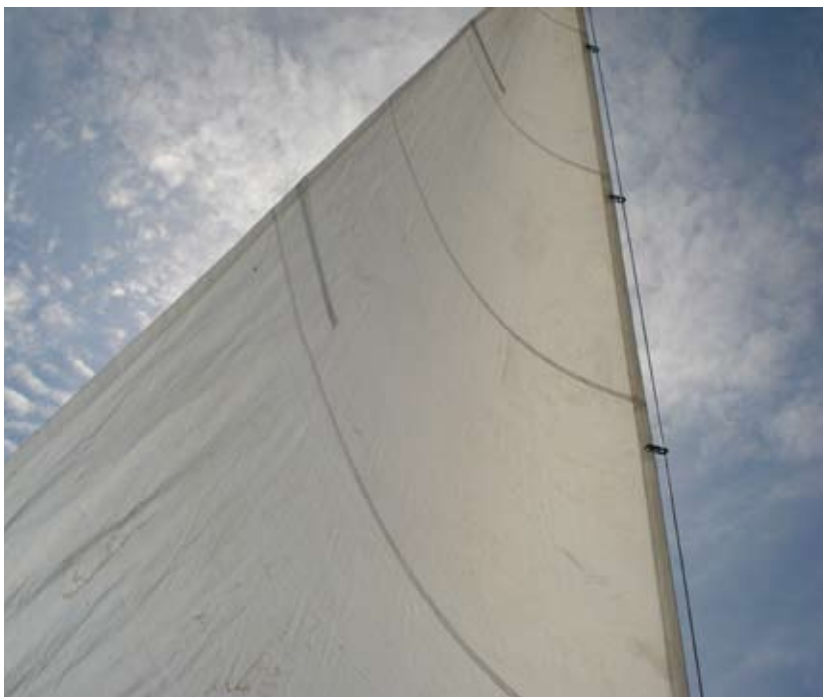
The profile of the jib was distorted along the battens, the leech was loose and the cloth had become way too soft. Rust stains were visual shortcomings.

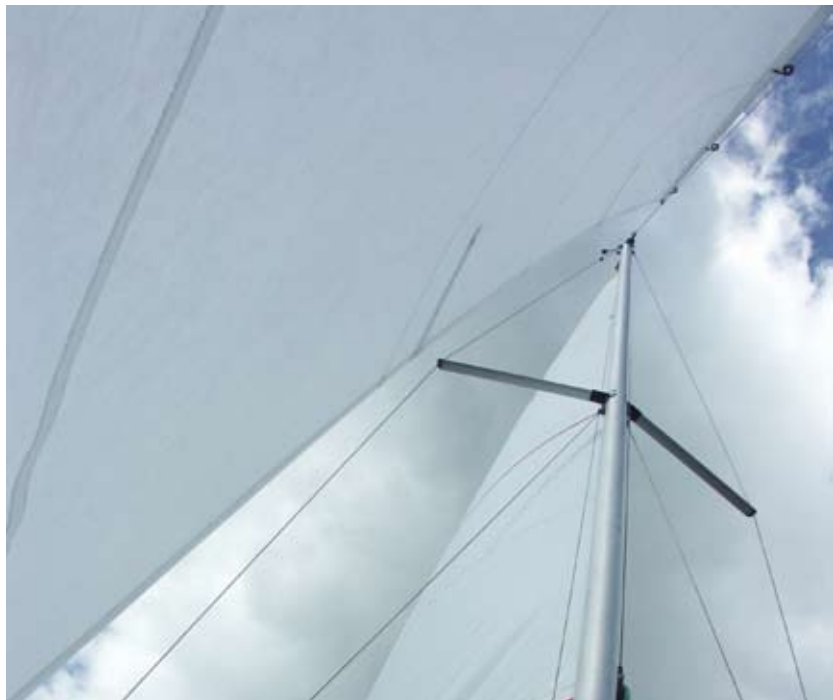
It could be clearly seen that the sails had become flatter, with the profiles being proper again. Main and jib can be trimmed easily and stay in shape even in stronger windspeeds.

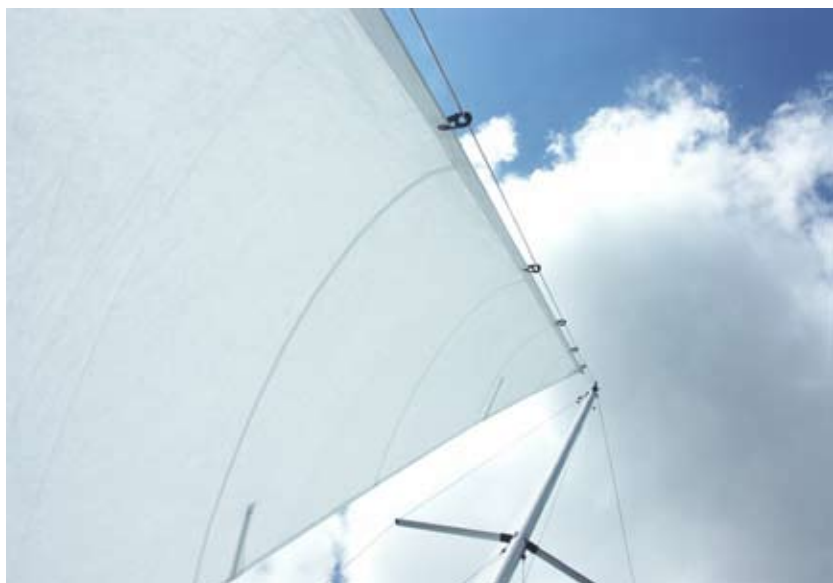
The deepest profile is now placed well forward, the leech is straight and undistorted. The jib performs well and allows high pointing.

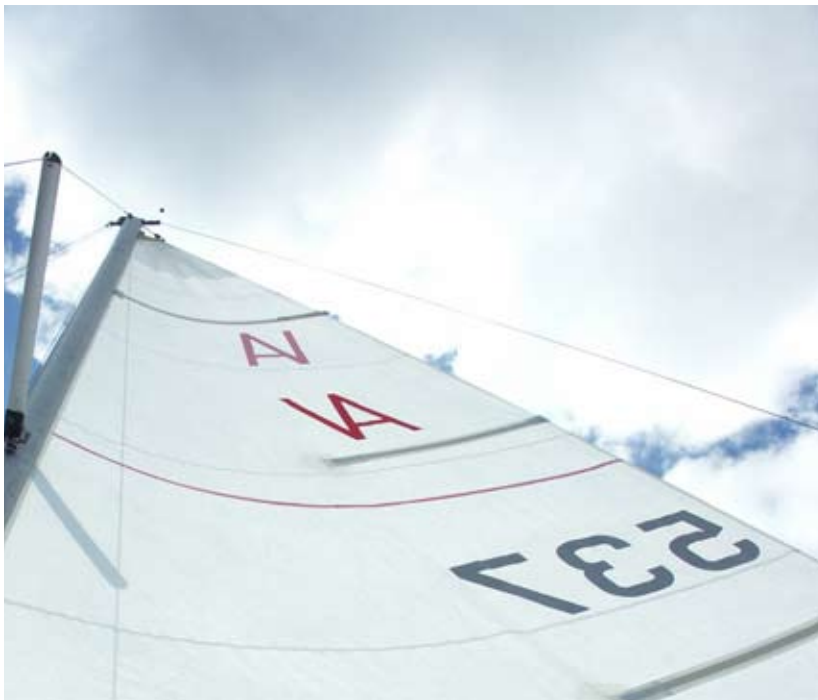
The shape of the main has improved impressively as well, the profile is flatter and responds well on trimming via luff- and outhaul-tension.

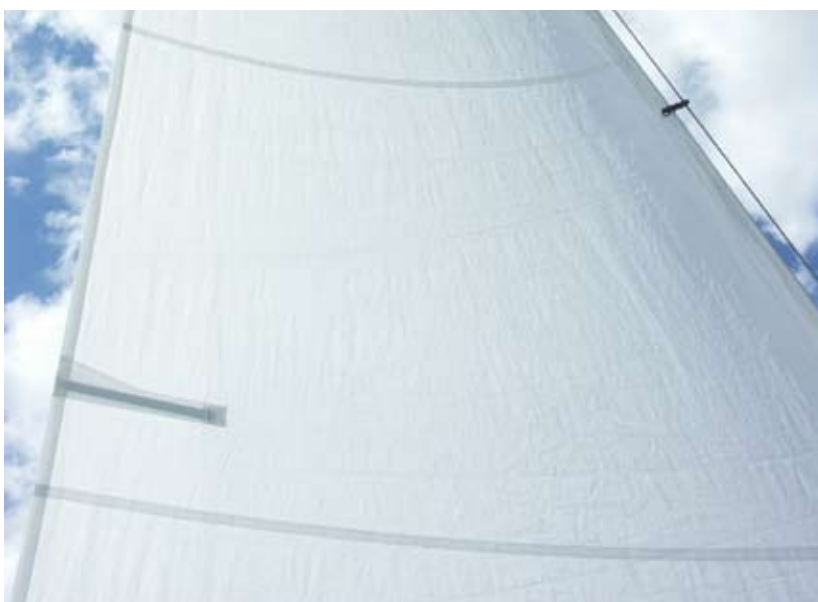
While the leech had to be controlled by a hard tensioned leechline before the treatment, now it can be left loose without spilling. The distortions in the cloth have disappeared as well.
